**CALIFORNIA DIVISION OF MINES AND GEOLOGY
FAULT EVALUATION REPORT FER-225
SAN ANDREAS FAULT AND RIDGETOP-SPREADING FISSURES
ASSOCIATED WITH THE OCTOBER 17, 1989 LOMA PRIETA EARTHQUAKE
SANTA CLARA AND SANTA CRUZ COUNTIES, CALIFORNIA**

**William A. Bryant
Associate Geologist
April 2, 1991**

**Division of Mines and Geology
630 Bercut Drive
Sacramento, CA 95814**

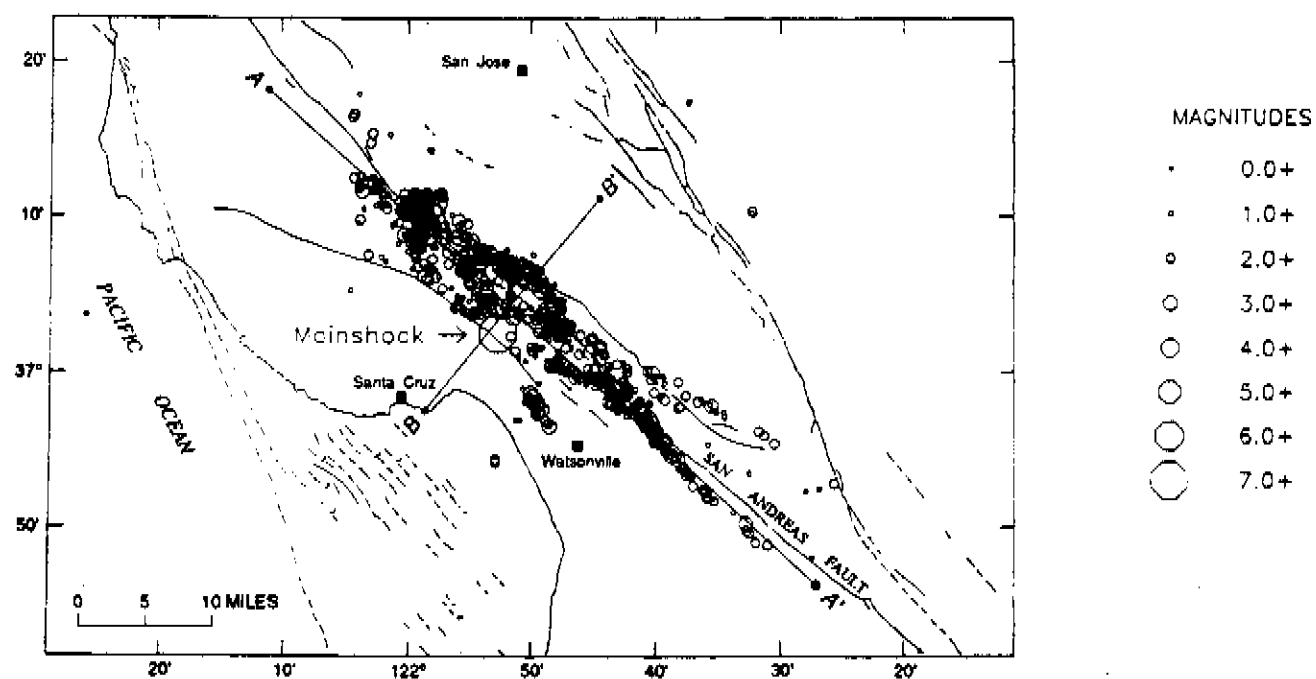
The M_s 7.1 Loma Prieta earthquake was located southwest of the San Andreas fault (Figures 1 and 5). The main shock focal mechanism indicated a 70° southwest-dipping reverse-oblique slip fault at a depth of 17.6 km (McNutt and Toppozada, 1990). Slip at depth along the fault was inferred to be 1.6 ± 0.3 meters of right-lateral strike-slip and 1.2 ± 0.3 meters of reverse slip (up on the southwest) (Plafker and Galloway, 1989). The aftershock zone was 53 km long after the first 4 days and had extended to 66 km by 31 October 1989 (Figure 5).

Figure 5 (to FER-225). Spatial distribution of aftershocks of the M_s 7.1 17 October 1989 Loma Prieta earthquake in relation to the San Andreas fault. (From Plafker and Galloway, 1989).
