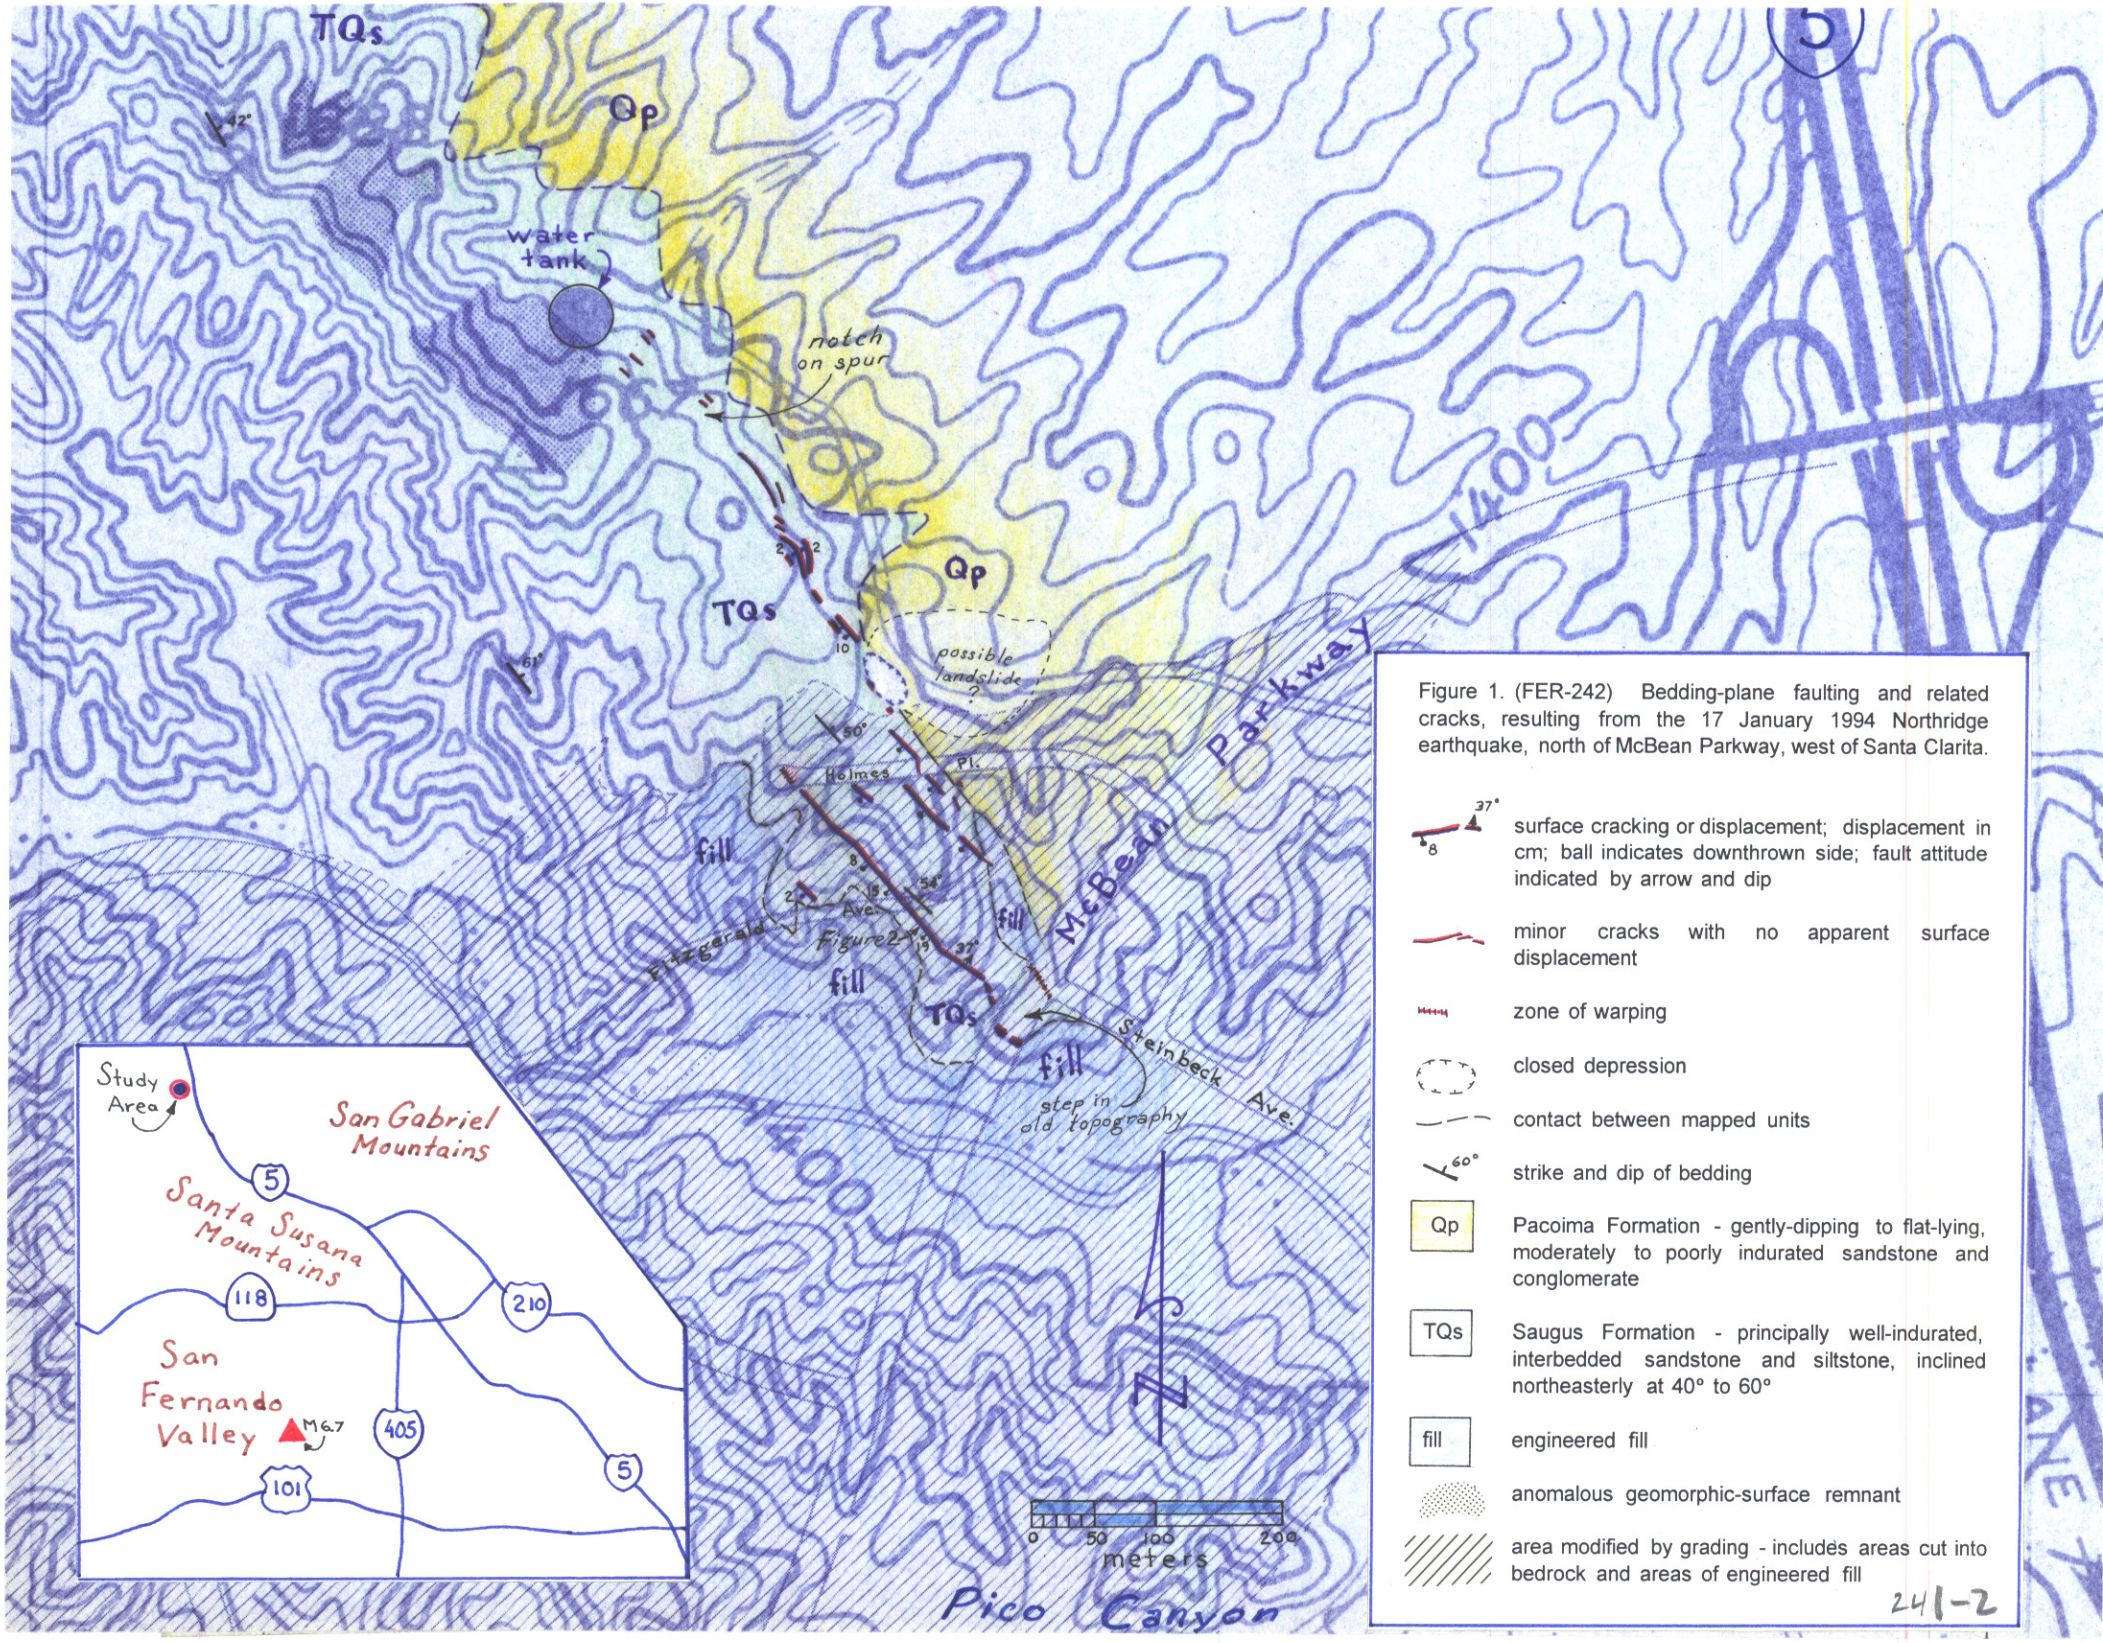
TQs
Qp
water tank
notch on spur
TQs
Qp
possible landslide ?
Holmes
Pl.
McBean Parkway
fill
Fitzgerald Ave.
Figure 2
fill
TQs
fill
Steinbeck Ave.
step in old topography
1400
1300
Pico Canyon
0 50 100 200
meters
Study Area
San Gabriel Mountains
Santa Susana Mountains
San Fernando Valley
M6.7
5
118
210
405
101
5
Figure 1. (FER-242) Bedding-plane faulting and related cracks, resulting from the 17 January 1994 Northridge earthquake, north of McBean Parkway, west of Santa Clarita.
surface cracking or displacement; displacement in cm; ball indicates downthrown side; fault attitude indicated by arrow and dip
minor cracks with no apparent surface displacement
zone of warping
closed depression
contact between mapped units
strike and dip of bedding
Qp
Pacoima Formation - gently-dipping to flat-lying, moderately to poorly indurated sandstone and conglomerate
TQs
Saugus Formation - principally well-indurated, interbedded sandstone and siltstone, inclined northeasterly at 40° to 60°

fill
engineered fill
anomalous geomorphic-surface remnant
area modified by grading - includes areas cut into bedrock and areas of engineered fill
241-2
