**CALIFORNIA DIVISION OF MINES AND GEOLOGY
FAULT EVALUATION REPORT FER-225
SAN ANDREAS FAULT AND RIDGETOP-SPREADING FISSURES
ASSOCIATED WITH THE OCTOBER 17, 1989 LOMA PRIETA EARTHQUAKE
SANTA CLARA AND SANTA CRUZ COUNTIES, CALIFORNIA**

**William A. Bryant
Associate Geologist
April 2, 1991**

**Division of Mines and Geology
630 Bercut Drive
Sacramento, CA 95814**

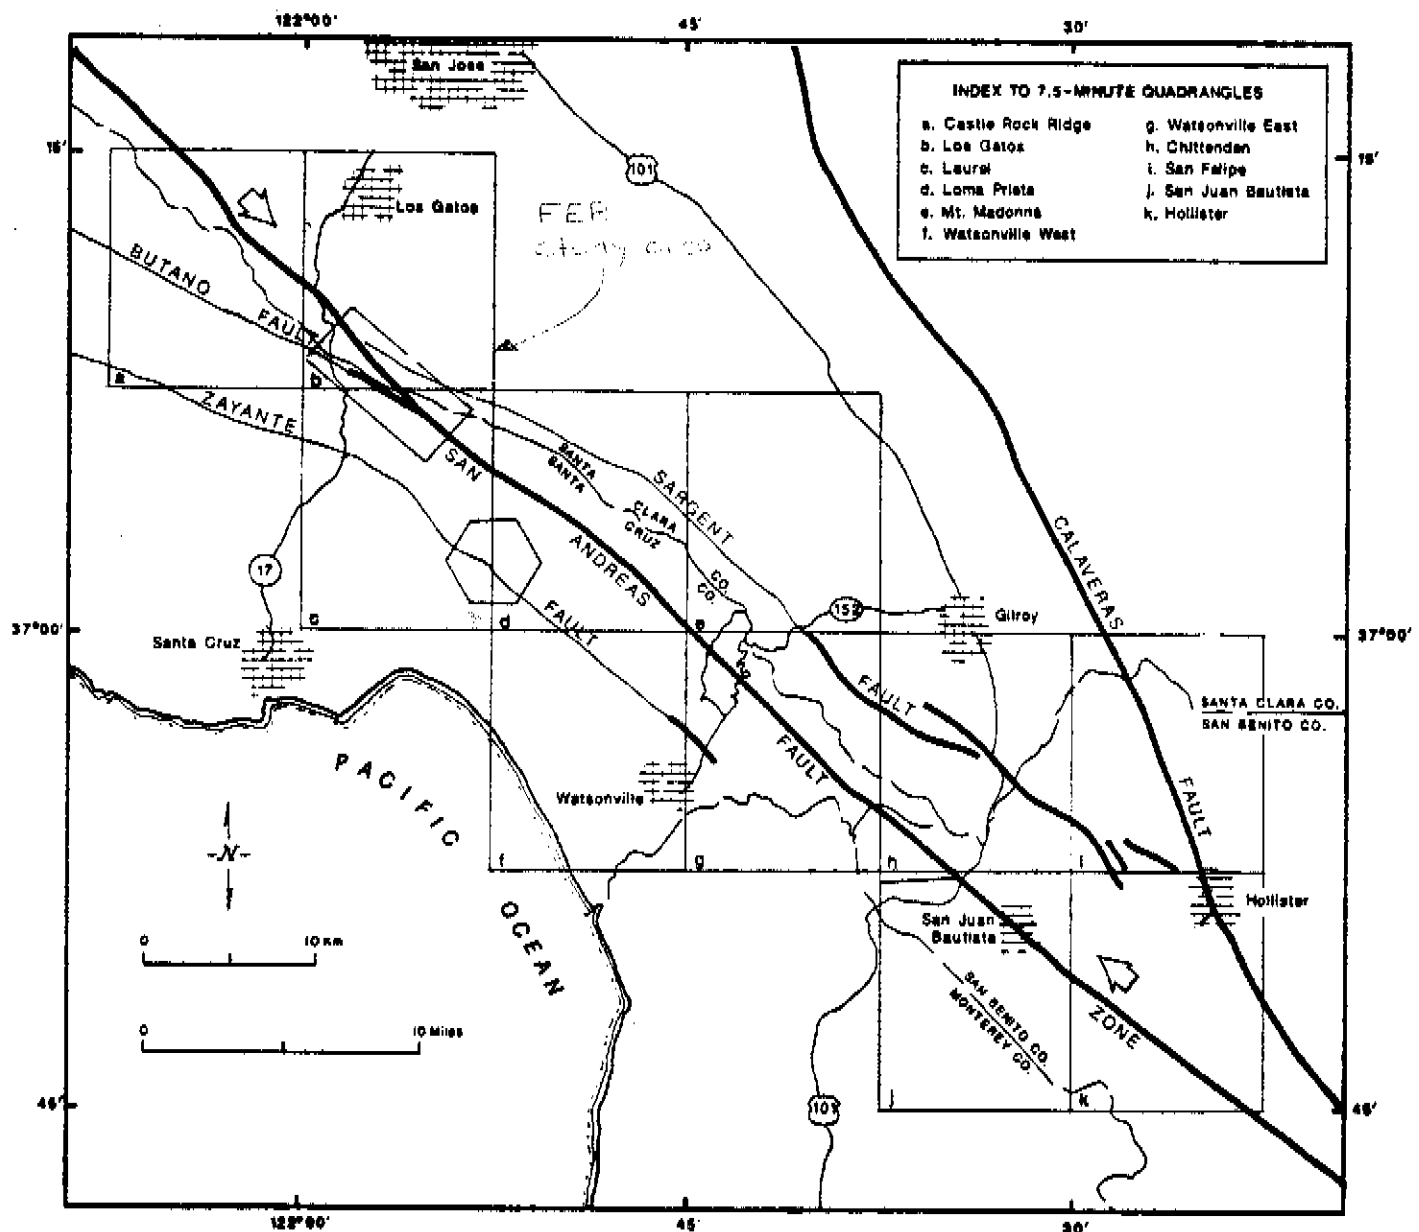
The M_s 7.1 Loma Prieta earthquake was located southwest of the San Andreas fault (Figures 1 and 5). The main shock focal mechanism indicated a 70° southwest-dipping reverse-oblique slip fault at a depth of 17.6 km (McNutt and Toppozada, 1990). Slip at depth along the fault was inferred to be 1.6 ± 0.3 meters of right-lateral strike-slip and 1.2 ± 0.3 meters of reverse slip (up on the southwest) (Plafker and Galloway, 1989). The aftershock zone was 53 km long after the first 4 days and had extended to 66 km by 31 October 1989 (Figure 5).

Figure 1 (to FER-225). Location of the San Andreas and related faults in the Summit Road/Skyland Ridge study area and ridgetop-spreading features and fissures associated with the 17 October 1989 Loma Prieta earthquake. Location of the M_w 7.1 epicenter is shown by the hexagon; arrows indicate the approximate extent of the mainshock subsurface rupture zone. (Modified from Hart and others, 1990).
